**PRUDENTIAL BUILDINGS: REPORT OF
WILLIAM M. EWING, CIH**

**William M. Ewing, CIH
Technical Director
Compass Environmental, Inc.
Robinson Road, Suite B
Marietta, Georgia 30068**

July 30, 1996

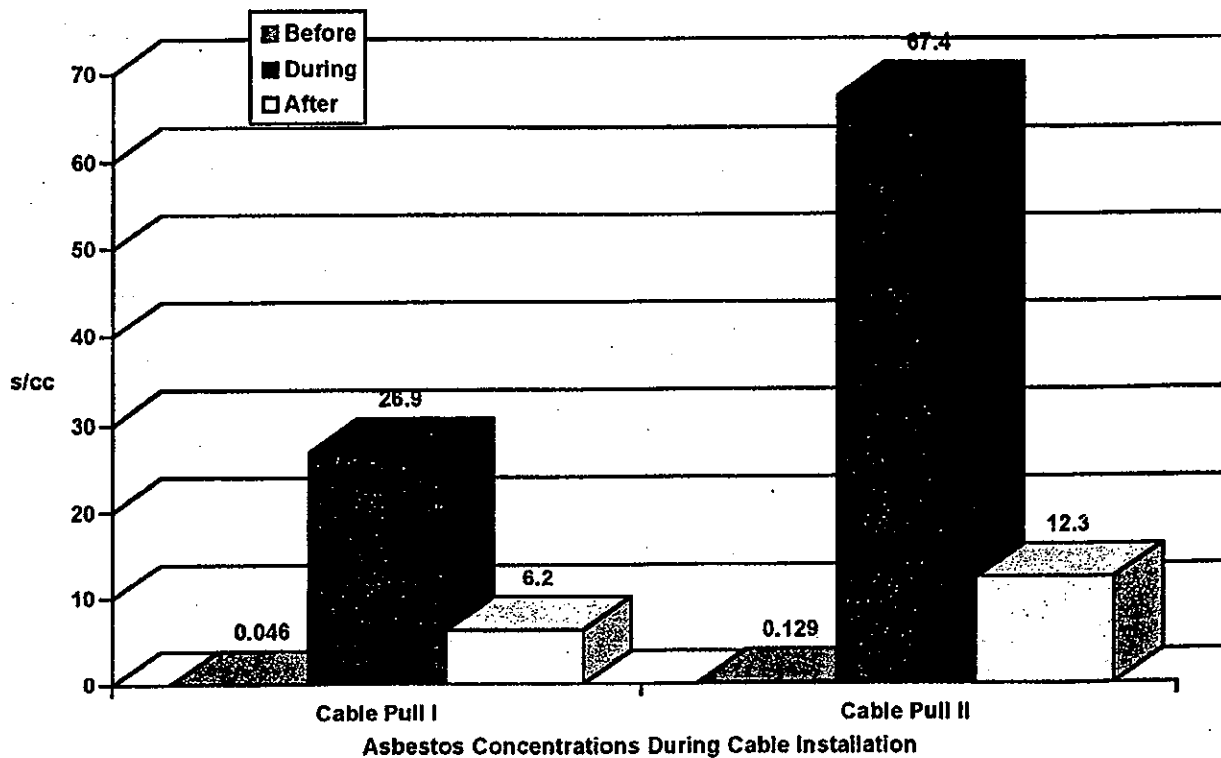
Figure 1. Episodic Exposure Results Before, During and After Installation of Cables in the Vicinity of High Density Fireproofing

Cable Pull I				
Phase	Arithmetic Mean (s/cm ³)	Arithmetic Std. Dev. (s/cm ³)	Geometric Mean	Number of Observations
Before Inst.	0.052	0.030	0.046	5
During Inst.	28.9	12.6	26.9	5
During (Pers.)	10.5	11.6	7.1	3
After Inst.	8.4	7.0	6.2	6

Cable Pull II				
Phase	Arithmetic Mean (s/cm ³)	Arithmetic Std. Dev. (s/cm ³)	Geometric Mean	Number of Observations
Before Inst.	0.158	0.094	0.129	5
During Inst.	100.2	91.9	67.4	4
During (Pers.)	124.8	85.6	102.7	3
After Inst.	17.0	13.5	12.3	4

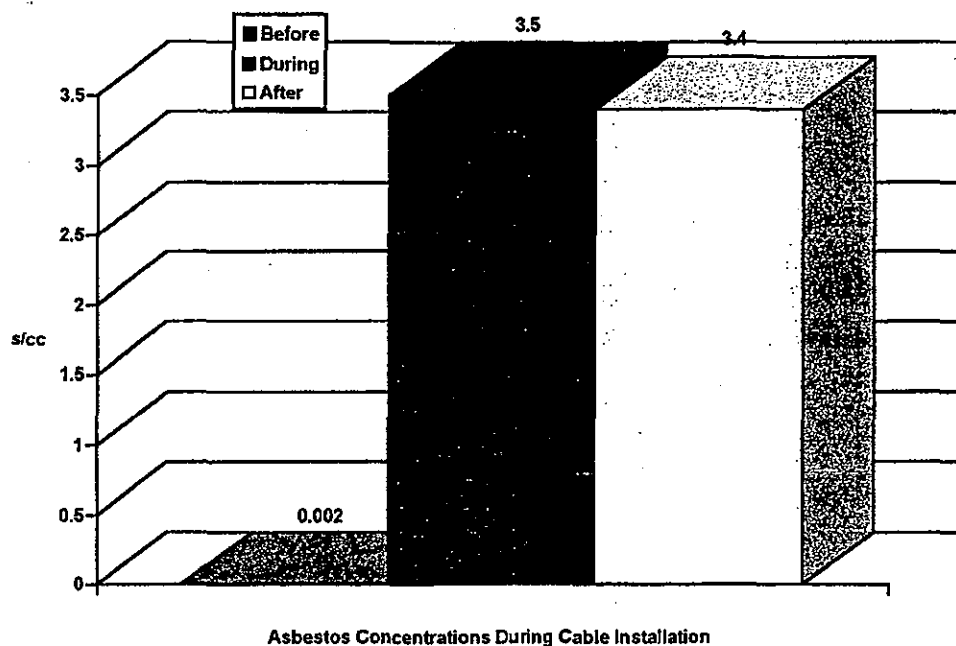
Figure 2. Episodic Exposure Results Before, During and After Installation of Cables in the Vicinity of Low Density Fireproofing

Phase	Arithmetic Mean (s/cm ³)	Arithmetic Std. Dev. (s/cm ³)	Geometric Mean	Number of Observations
Before	0.006	0.014	0.002	5
During (Area)	3.6	0.84	3.5	5
During (Pers.)	26	7.5	26	2
After	3.8	1.9	3.4	5

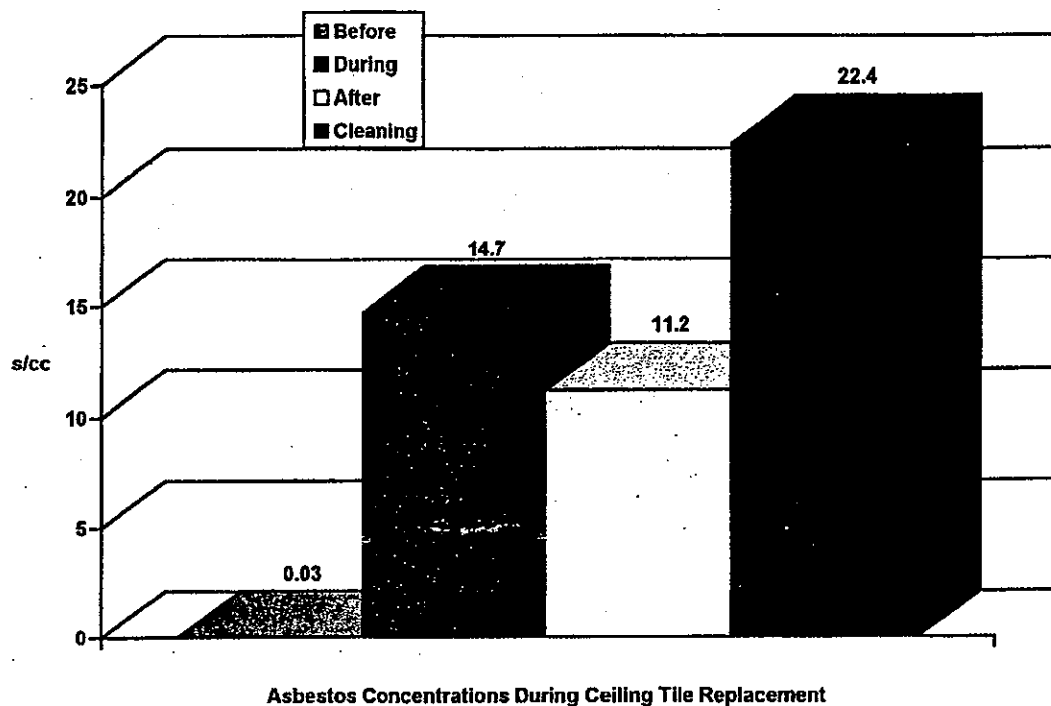
Figure 3. Episodic Exposure Results Before, During, and After Replacement of Ceiling Tiles Below Fireproofing

Phase	Arithmetic Mean (s/cm ³)	Range (s/cm ³)	Geometric Mean (s/cm ³)	Number of Observations
Before	0.05	ND - 0.08	0.03	5
During	15.3	10 - 20	14.7	5
During (Pers.)	23.0	22 - 24	23.0	2
After	11.4	9 - 14	11.2	5
Cleaning	22.4	20 - 24	22.4	5

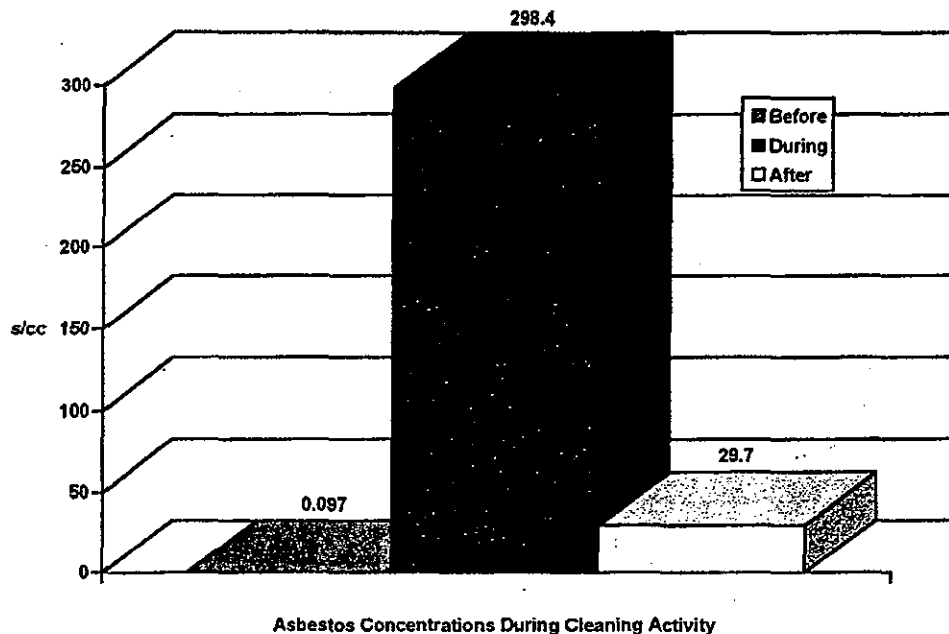
Figure 4. Episodic Exposure Results Before, During and After Cleaning a Storage Room in a Building with Fireproofing

Phase	Arithmetic Mean (s/cm ³)	Arithmetic Std. Dev. (s/cm ³)	Geometric Mean	Number of Observations
Before - Inside	0.264	0.221	0.097	5
During - Inside	329.9	173.0	298.4	5
During - Inside (Personal)	343.8	360.6	237.1	3
After - Inside	31.8	12.3	29.7	5

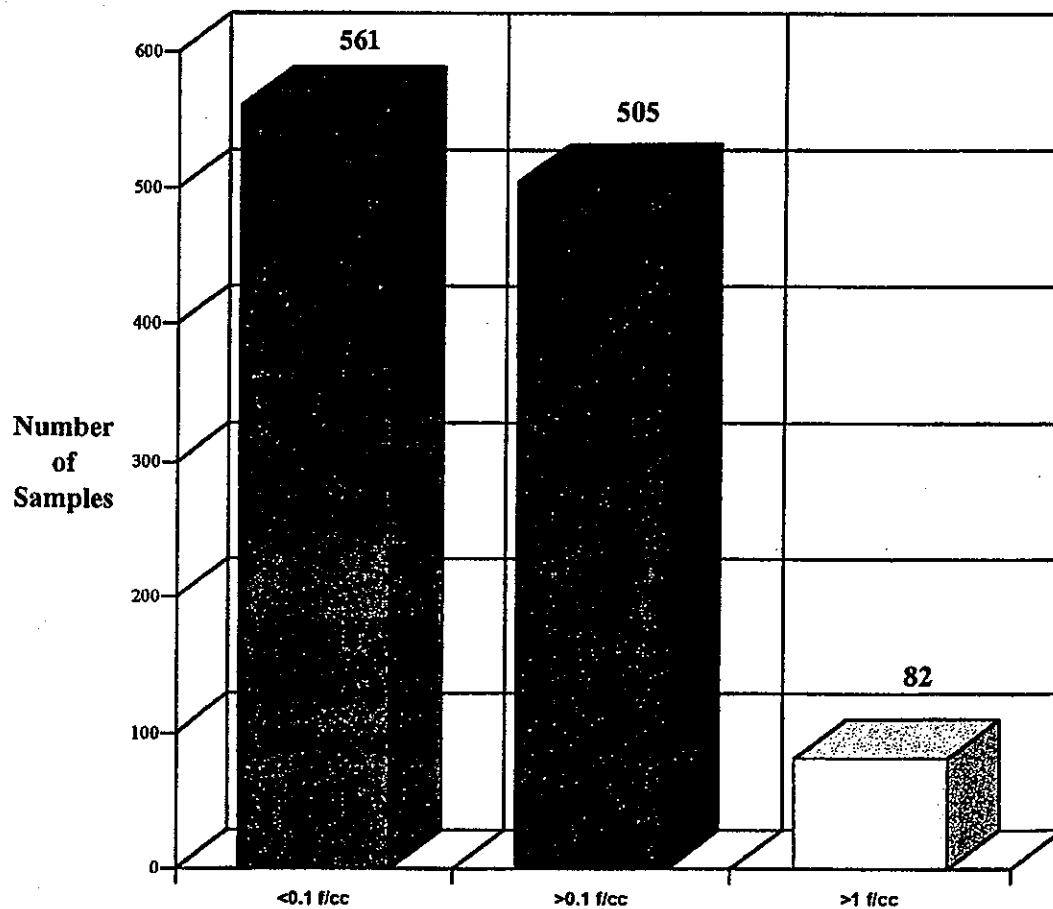
Figure 6. Distribution of Fiber Concentrations Measured on Persons Performing Maintenance and Renovation Activities in Prudential Buildings (1066 samples)

20
21 Of the 1066 personal samples, 505 (47%) were greater than or equal to 0.1 f/cc and 82
22 (8%) were greater than 1 f/cc. These results are depicted in Figure 6. These results are

1 consistent with results reported in the published literature and further demonstrate that
2 maintenance and renovation activities in buildings with spray-applied friable fireproofing
3 routinely cause elevated airborne exposures.
